Flood Control Project Maintenance
2011 Structure Summary Report
Overall Unit and Item Ratings

Sacramento County

American River Pumping Plant No. 1 Howe Avenue Storm Drain D - 05

American River Pumping Plant No. 2 Willhaggin Storm Drain D - 43

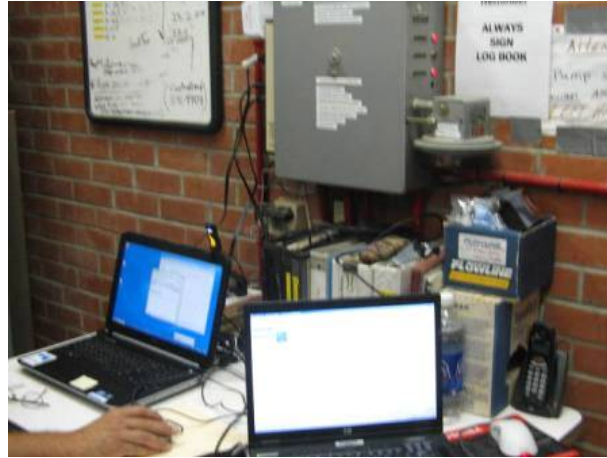
Levee Mile Report Line	1
Start Levee Mile	0.00
End Levee Mile	0.00
Location	
Category	Pump Stations
Item	Operating Log

08/05/2011 Photo shows desk with maintenance log and O & M manuals on site.

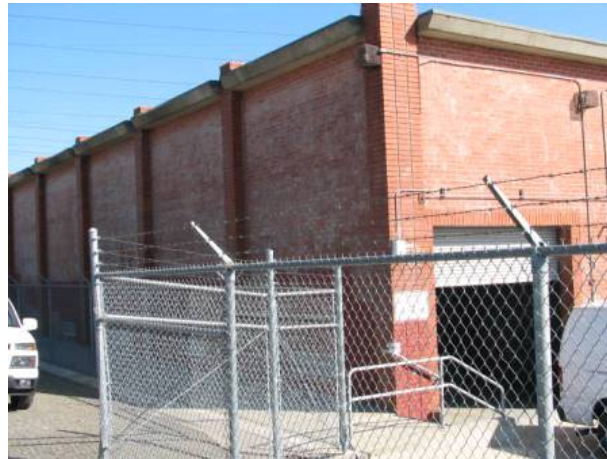
Levee Mile Report Line	3
Start Levee Mile	0.00
End Levee Mile	0.00
Location	
Category	Pump Stations
Item	Plant Building

08/05/2011 Photo shows building at pump station facility.

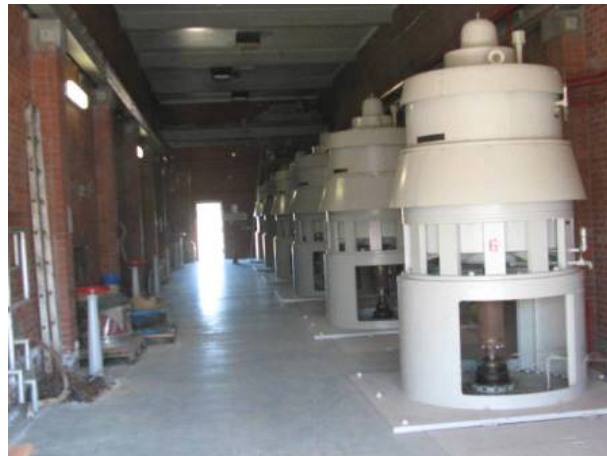
Levee Mile Report Line	7
Start Levee Mile	0.00
End Levee Mile	0.00
Location	
Category	Pump Stations
Item	Pumps

08/05/2011 Photo shows all six pumps. Note, crane is in the background.

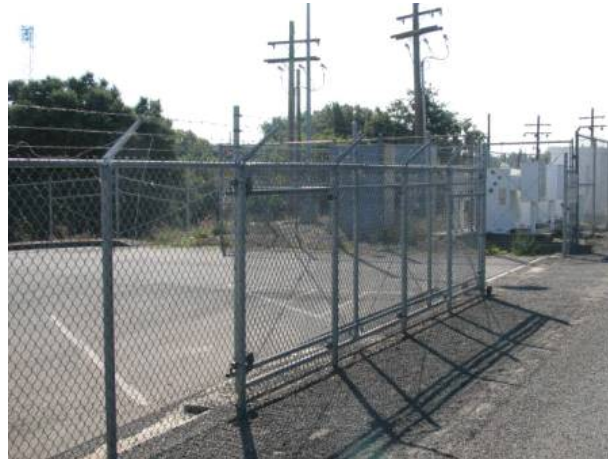
Levee Mile Report Line	8
Start Levee Mile	0.00
End Levee Mile	0.00
Location	
Category	Pump Stations
Item	Power

08/05/2011 Photo shows security fencing, power source and backup generator located in the background.

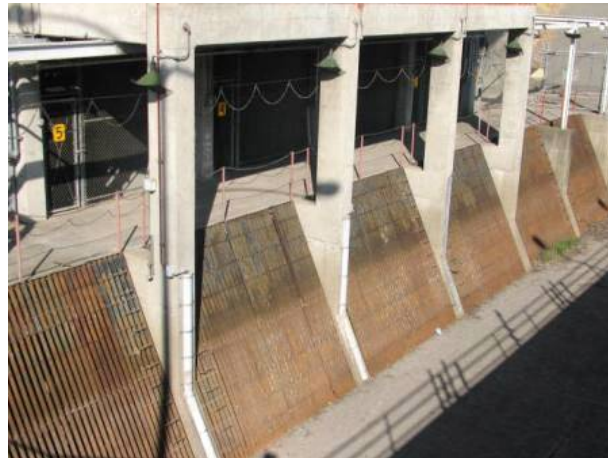
Levee Mile Report Line	12
Start Levee Mile	0.00
End Levee Mile	0.00
Location	
Category	Pump Stations
Item	Trash Racks

°	°	
12	0.00	0.00	Pump Stations	Trash Racks		A	Inspector Comments: Trash racks are in place, properly maintained and clear of any debris.	°	°	13
								°	°	Y

08/05/2011 Photo shows trash racks.

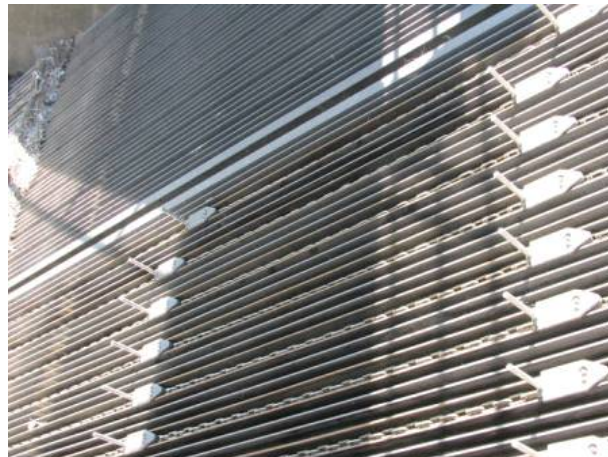
Levee Mile Report Line	13
Start Levee Mile	0.00
End Levee Mile	0.00
Location	
Category	Pump Stations
Item	Trash Rakes

08/05/2011 Close up photo of trash rake, note cleanliness and free of debris.

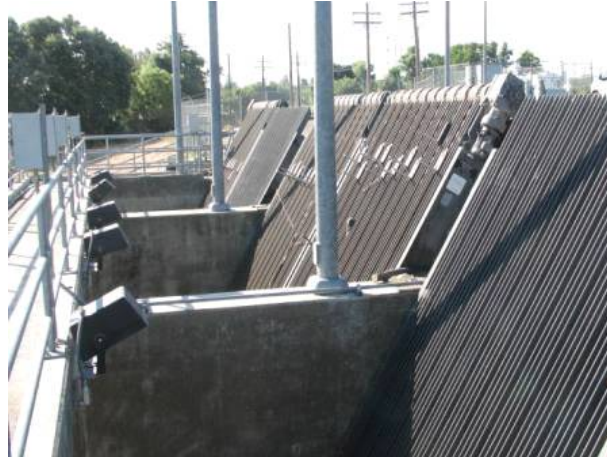
Levee Mile Report Line	13
Start Levee Mile	0.00
End Levee Mile	0.00
Location	
Category	Pump Stations
Item	Trash Rakes
08/05/2011 Extended photo of trash rakes.	
jeto_t_20110809_018.jpg

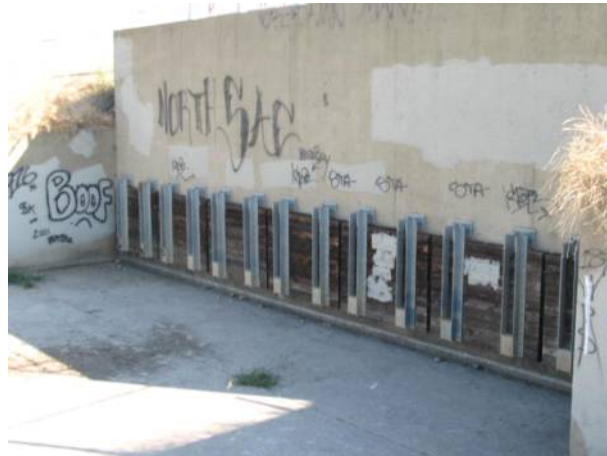
Levee Mile Report Line	18
Start Levee Mile	0.00
End Levee Mile	0.00
Location	
Category	Pump Stations
Item	Flap Gates
08/05/2011 Photo shows flap gates at pump station outfall structure.	
jeto_t_20110809_019.jpg

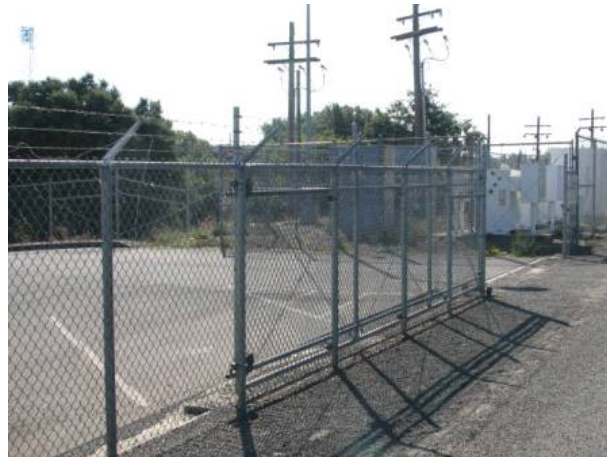
Levee Mile Report Line	20
Start Levee Mile	0.00
End Levee Mile	0.00
Location	
Category	Pump Stations
Item	Security Fencing
08/05/2011 Photo shows security fencing. Note, same photo was used to show electrical and emergency power supply.	
jeto_t_20110809_020.jpg

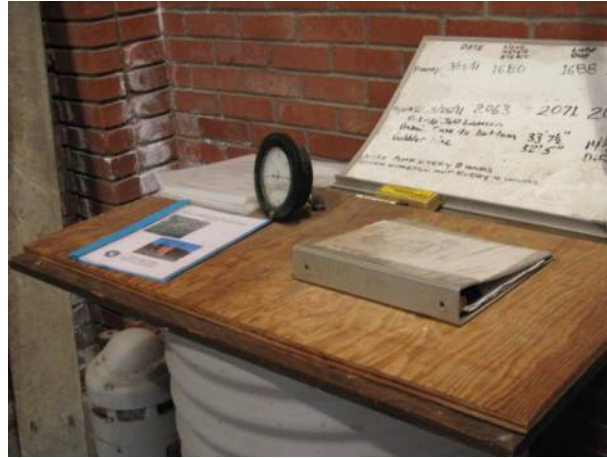
Levee Mile Report Line	1
Start Levee Mile	0.00
End Levee Mile	0.00
Location	
Category	Pump Stations
Item	Operating Log

08/05/2011 Photo shows operating log on site.

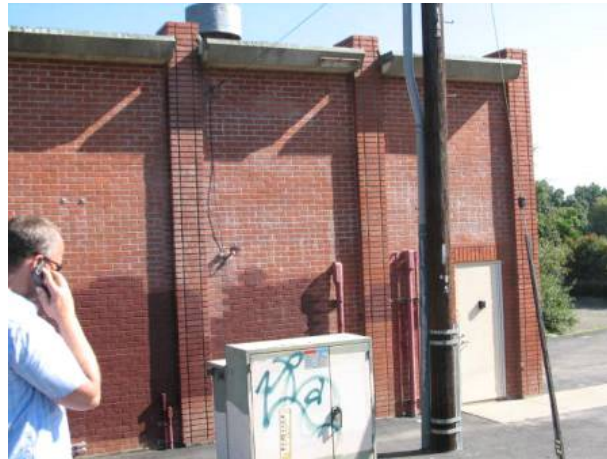
Levee Mile Report Line	3
Start Levee Mile	0.00
End Levee Mile	0.00
Location	
Category	Pump Stations
Item	Plant Building

08/05/2011 Photo of pumping plant structure.

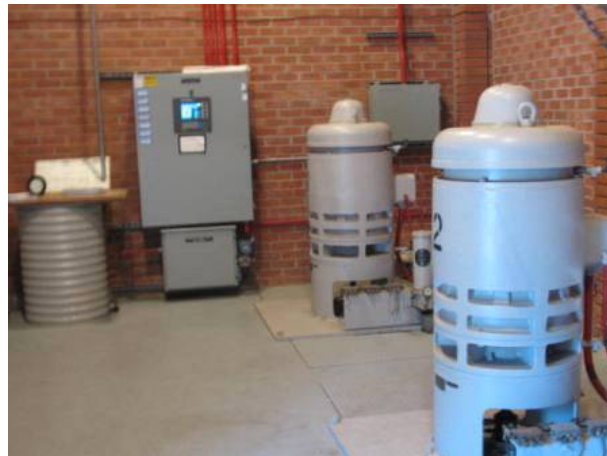
Levee Mile Report Line	7
Start Levee Mile	0.00
End Levee Mile	0.00
Location	
Category	Pump Stations
Item	Pumps

08/05/2011 Photo showing two of the pump motors.

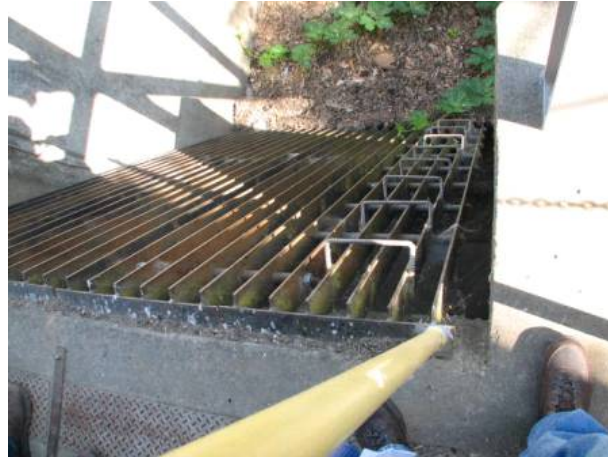
Levee Mile Report Line	12
Start Levee Mile	0.00
End Levee Mile	0.00
Location	
Category	Pump Stations
Item	Trash Racks
08/05/2011 Photo shows properly maintained trash rack free of debris.	
jeto_t_20110809_025.jpg

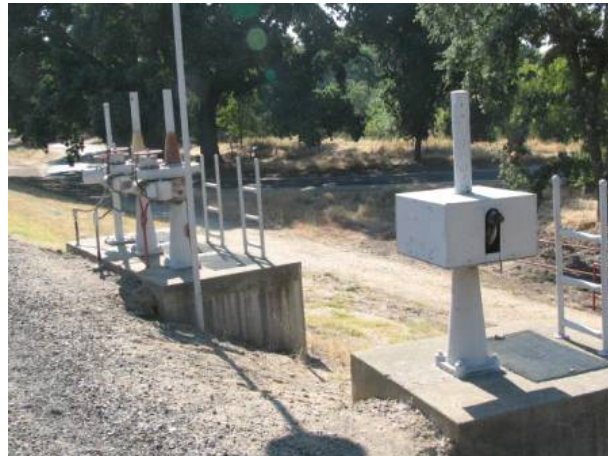
Levee Mile Report Line	15
Start Levee Mile	0.00
End Levee Mile	0.00
Location	
Category	Pump Stations
Item	Electric Gate Operators
08/05/2011 Photo shows gate controls.	
jeto_t_20110809_026.jpg

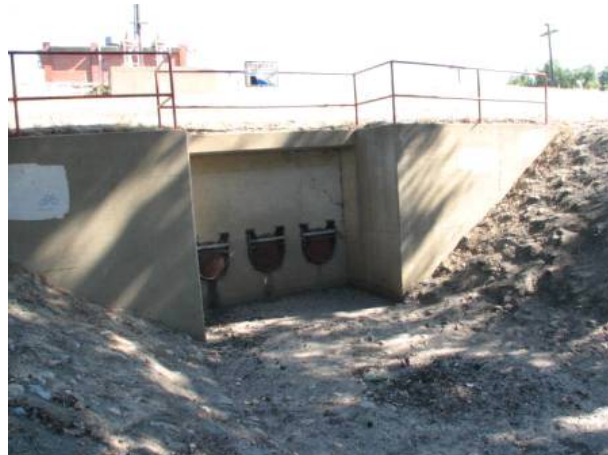
18	0.00	0.00	Pump Stations	Flap Gates		A	Inspector Comments: Flap gates are visible and appear to be in working order, there was no flow to test for leakage.	38.584904 ° -121.421534 °	38.584904 ° -121.421534 °	19 Y
19	0.00	0.00	Pump Stations	Closure Structures		N	Item inspected visually only. Item was not operated during the inspection. Inspector Comments: Slide/Sluice gates act as closure structures. They are not visible for inspection.	38.584904 ° -121.421534 °	38.584904 ° -121.421534 °	20
20	0.00	0.00	Pump Stations	Security Fencing		A	Inspector Comments: Security fencing encloses standby generator. Building is securely locked.	38.584904 ° -121.421534 °	38.584904 ° -121.421534 °	21
21	0.00	0.00	Pump Stations	Intake and Discharge Pipes		A	Inspector Comments: No visible defects in pipes.	38.584904 ° -121.421534 °	38.584904 ° -121.421534 °	22
22	0.00	0.00	Pump Stations	Pressurized Pipe		A	Inspector Comments: There is no evidence of erosion or leakage around pipe, or corrosion of the pipe.	38.584904 ° -121.421534 °	38.584904 ° -121.421534 °	23

Levee Mile Report Line	18
Start Levee Mile	0.00
End Levee Mile	0.00
Location	
Category	Pump Stations
Item	Flap Gates
08/05/2011 Photo shows flap gates on water side.	
jeto_t_20110809_027.jpg
